TROUBLESHOOTING & MAINTENANCE

Utility Yard Hydrant Lever Handle Models

Utility Yard Hydrant Operating Pipe Removal (Lever Handle Models)

Utility Yard Hydrant Wheel Handle Models

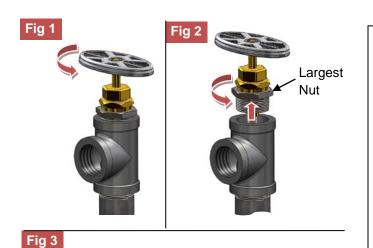
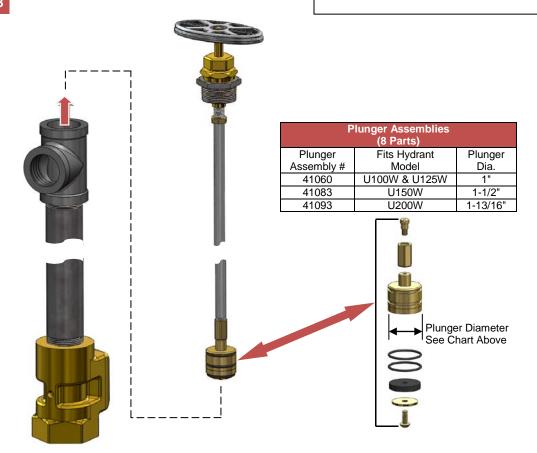
- Shut off water supply to hydrant. 1.
- 2. Turn Handle to full open position. Fig 1
- 3. Unthread the largest Nut from the Tee or casting. Fig 2
- 4. Pry the Rod Assembly loose from the Valve Seat and remove the entire Rod Assembly. Fig 2 & 3
- 5. Inspect Plunger Rubber, O-rings and Seals for damage. Plunger Assemblies are available for all Utility Hydrant models.
