TROUBLESHOOTING & MAINTENANCE

R34 Yard Hydrant Packing Replacement

Rev 06/15 Form No. TMYH-1.104

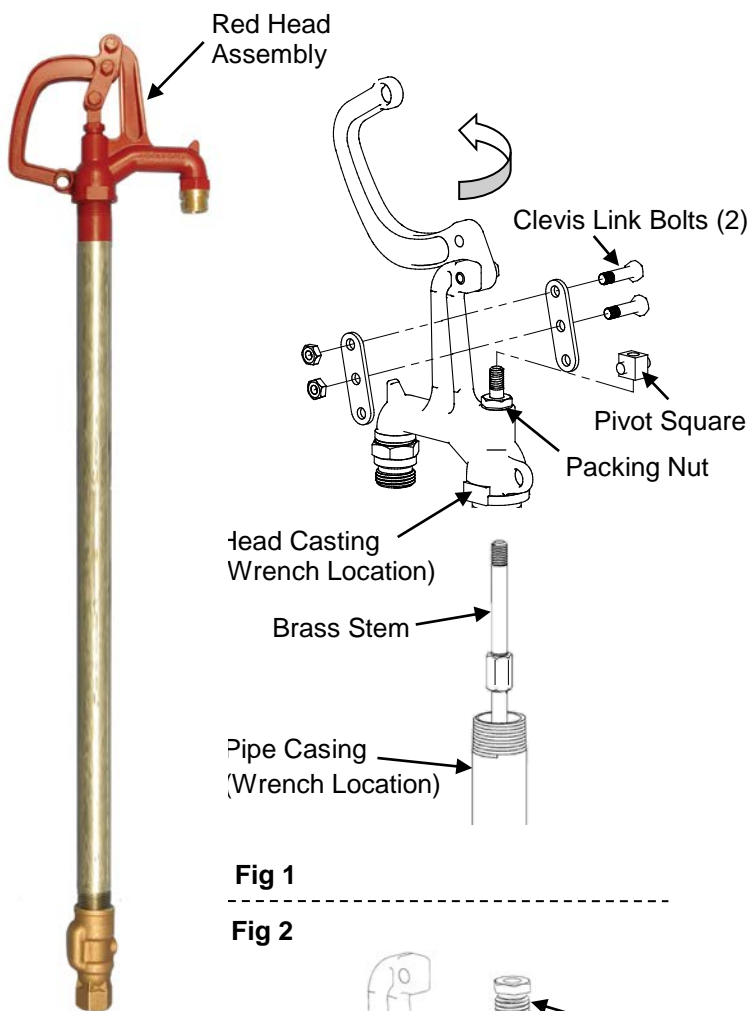
1. Shut off water supply to hydrant.
2. Lift the Handle to the open position. Fig 1
3. Remove the two Link Bolts and rotate handle out of the way. Fig 1
4. Unscrew and remove the Pivot Block. Fig 1

5. Loosen the Packing Nut. Fig 1
6. Remove the head casting using two pipe wrenches, one on head casting and the other on the pipe. Fig 2
7. Remove the Packing Nut. Fig 2
