# TROUBLESHOOTING & MAINTENANCE

Rev 06/15 Form No. TM68.101

## Model 68 Freezeless UNDERCOVER WALL HYDRANT™

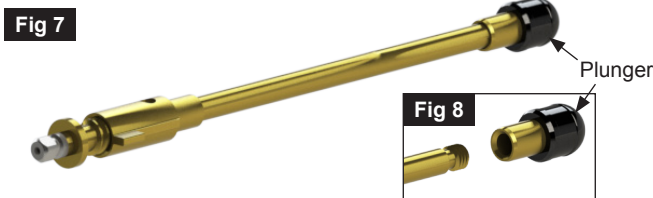
1. Shut off water supply.
2. Use the Tee Key and turn the Stem Screw counter-clockwise to the full open position. (Fig 4)
3. Remove the Head Nut and Stem Screw. (Fig 5)
4. Remove the "C" Washer from the stem screw. (Fig 5)
5. Thread the stem screw back in the operating rod one or two turns. (Fig 6) Use a screwdriver or small pry bar to pry under the ledge of the stem screw, against the face of the hydrant, to pull the rod out of the hydrant. A damaged plunger may require a significant force to pull the rod free. (Fig 7)
6. Once the rod is out of the hydrant, inspect and/or replace the plunger, which is threaded on the rod. (Fig 7 & 8) If the plunger rubber has come off the insert and is stuck inside the hydrant, a special plunger removal tool is available on loan from Woodford.
